Property Inspection Report

123 Inspection Ln, Menifee, CA 92585
Inspection prepared for: John Sample
Date of Inspection: 3/11/2019 Size: 2600 sq.ft.

Inspector: Peter A. Tarutis

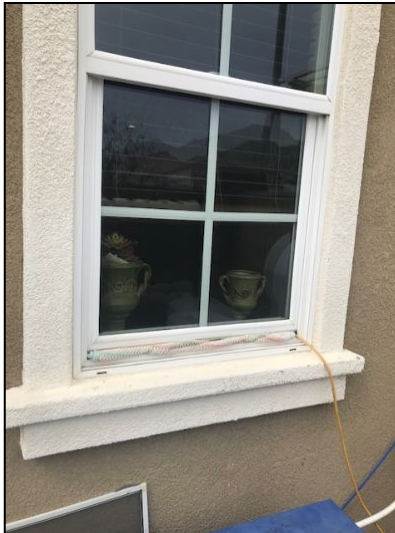
10. Window Condition

- ✓ Observations:
 - **Missing screens observed at kitchen window. Recommended repair/replace**

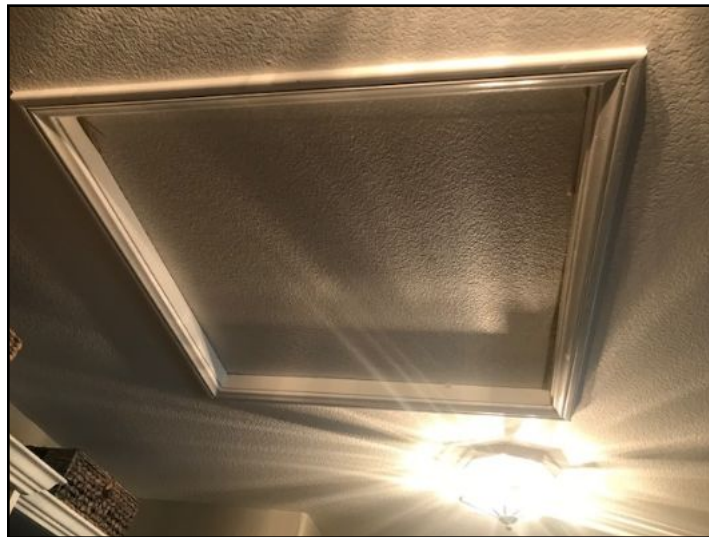
- ✓ Scuttle Hole located in: Master Bathroom Closet
- ✓ Garage ceiling.
- ✓ Attic light located just inside access.
- **IMPROVE:** The attic access is not insulated. Expect some energy loss through convection. Recommend insulating attic access hatch cover@@pull down ladder@@ with a batt of fiberglass insulation to reduce energy expenses. See diagram for detail.

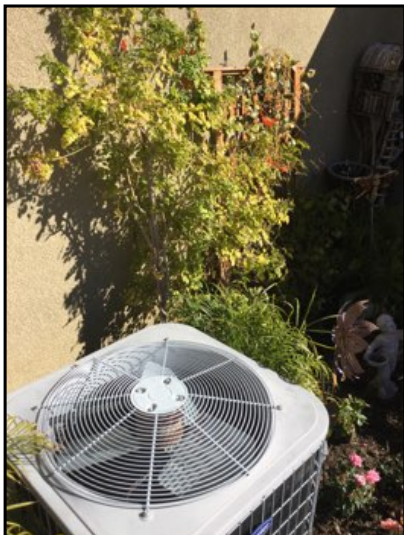
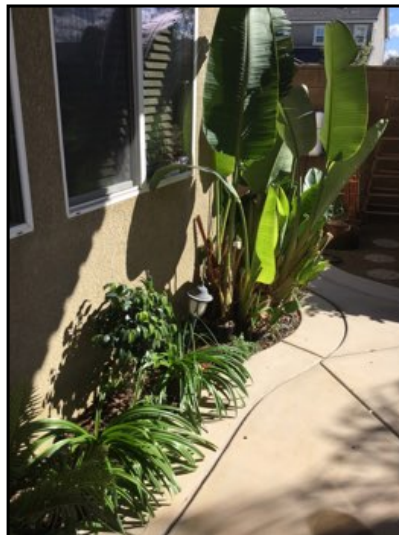
- 🔍
 - Prune or remove any plants that are in contact or proximity to home to eliminate pathways of wood destroying insects.
 - Maintenance Tip: When landscaping, keep plants, even at full growth, at least a foot (preferably 18 inches) from house siding and windows. Keep trees away from foundation and roof. Plants in contact or proximity to home can provide pathways for wood destroying insects, as well as abrade and damage siding, screens and roofs.
